Algonquin Rd. at the Union Pacific freight line between Mt Prospect and Wolf

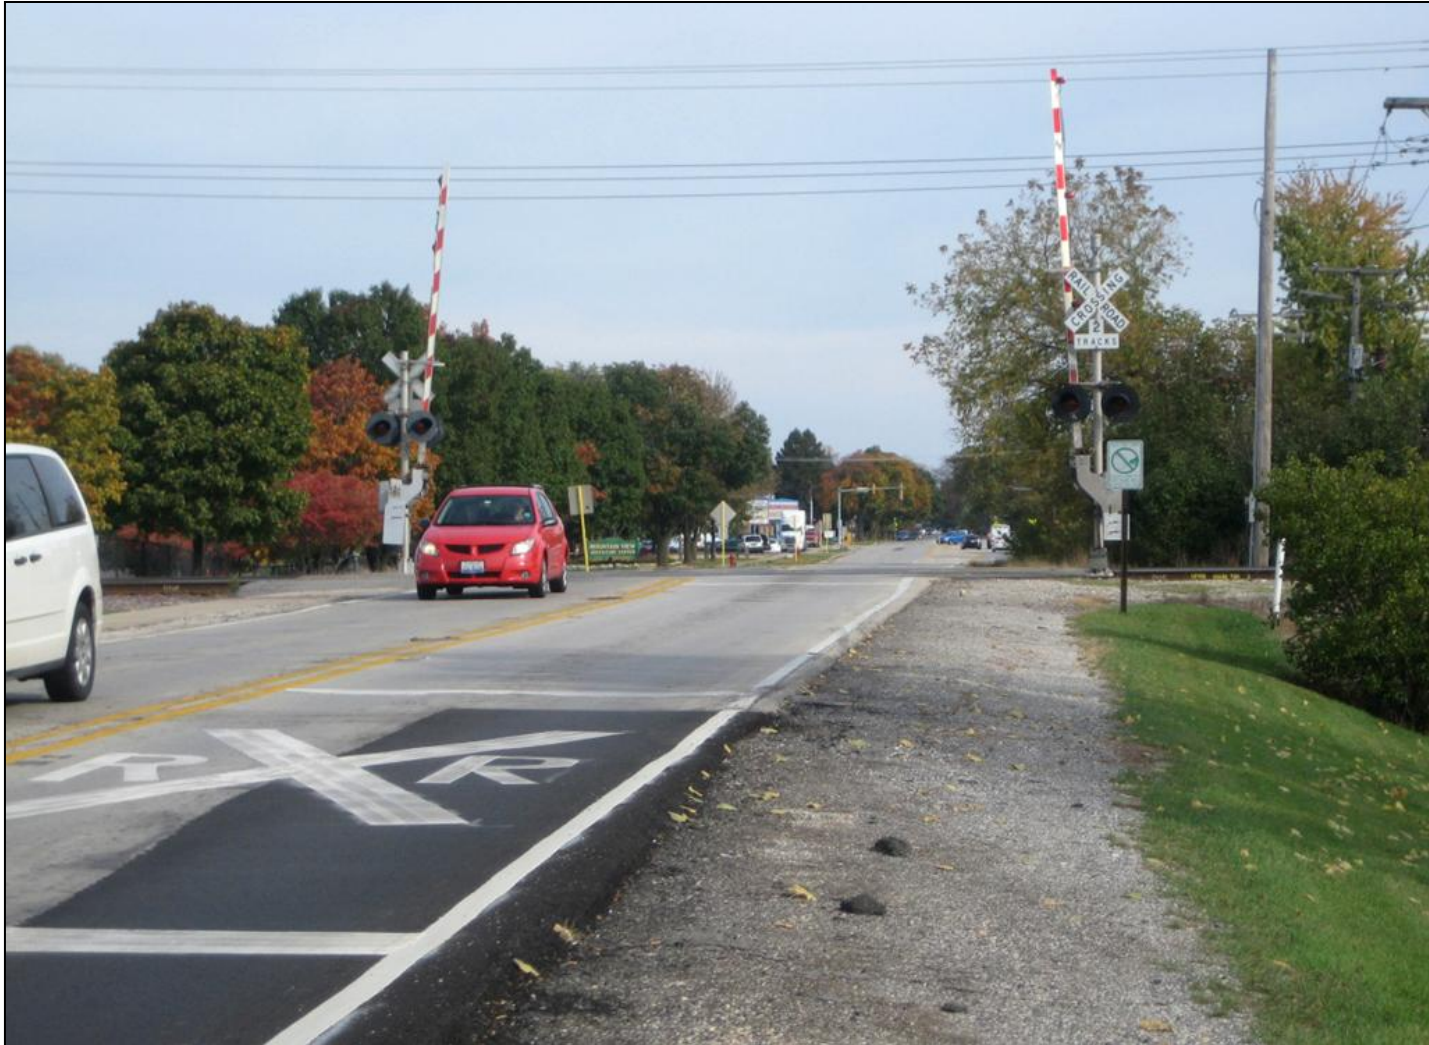
This is a very difficult place for bikes to navigate. The road narrows towards the crossing, and traffic is often pretty heavy. You've got a choice between an uneven, debris-strewn shoulder and riding right on the white painted line, with a hazardous edge of pavement just adjacent (drop of several inches, enough to throw you off balance. All that is needed here is maybe 18" of additional asphalt outside the traffic lane.
